Sales & Application Note N1- CB19

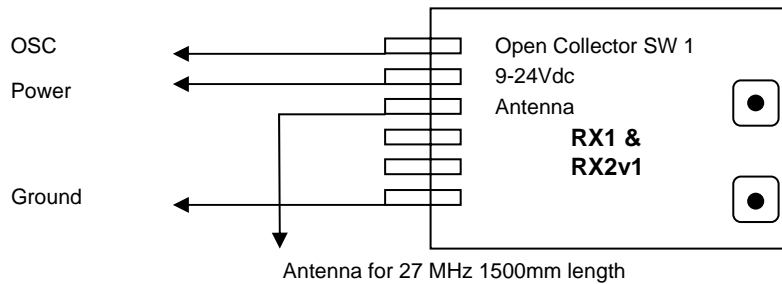
1. RX1 & RX2v1

These receivers can be wired in to CB-19 boards using a harness # 01905.
 Please ensure a suitable antenna wire is used 27MHz 1500mm length.

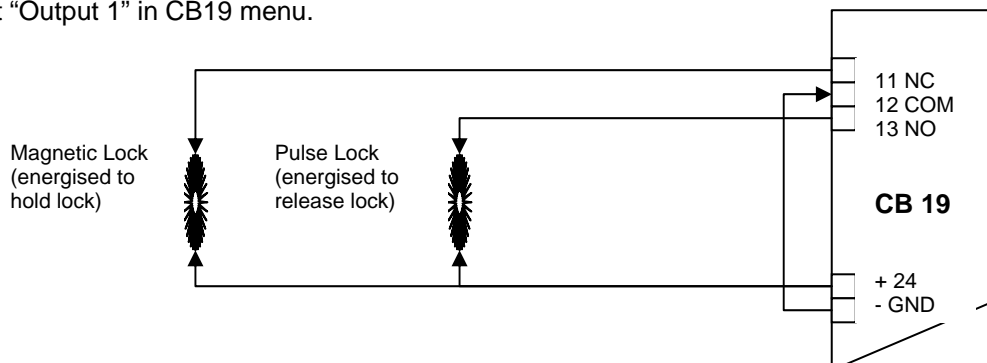
○ Gate Solenoid Lock:

Set "Output 1" in CB19 menu.

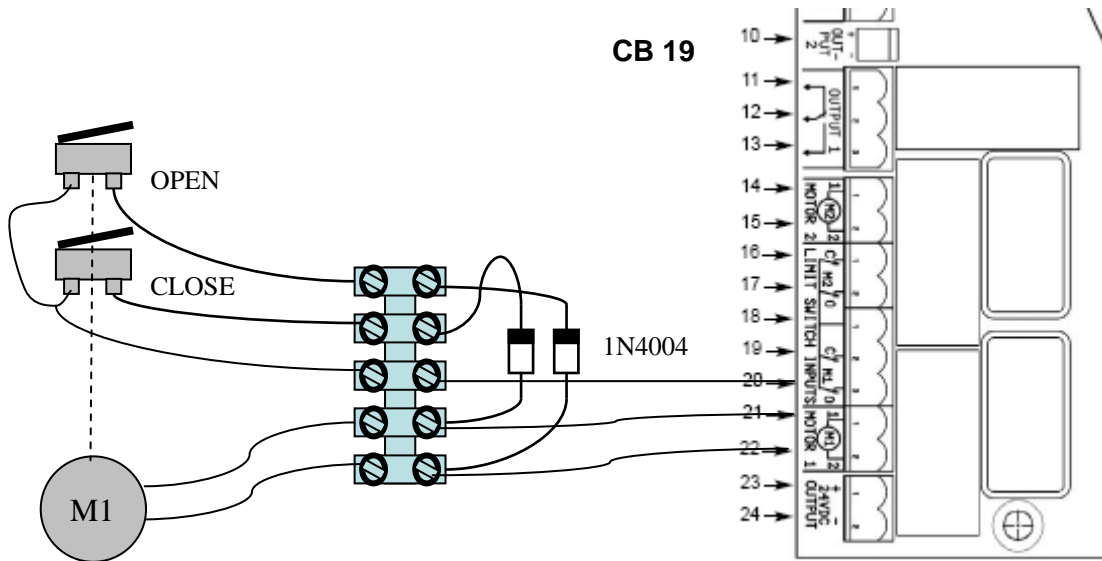
○ **3 Wire Terminal Block:**

Wiring details when using a terminal block for a 3 wire system. Duplicate for M2 wiring, see page 6 of the CB19 manual.
